# A study on deterioration and residual service life of recovered azobé (*Lophira alata*) sheet piles

Abhijith Kamath<sup>1</sup> · Michele Mirra<sup>1</sup> · Geert Ravenshorst<sup>1</sup> · Jan-Willem van de Kuilen<sup>1,2</sup>

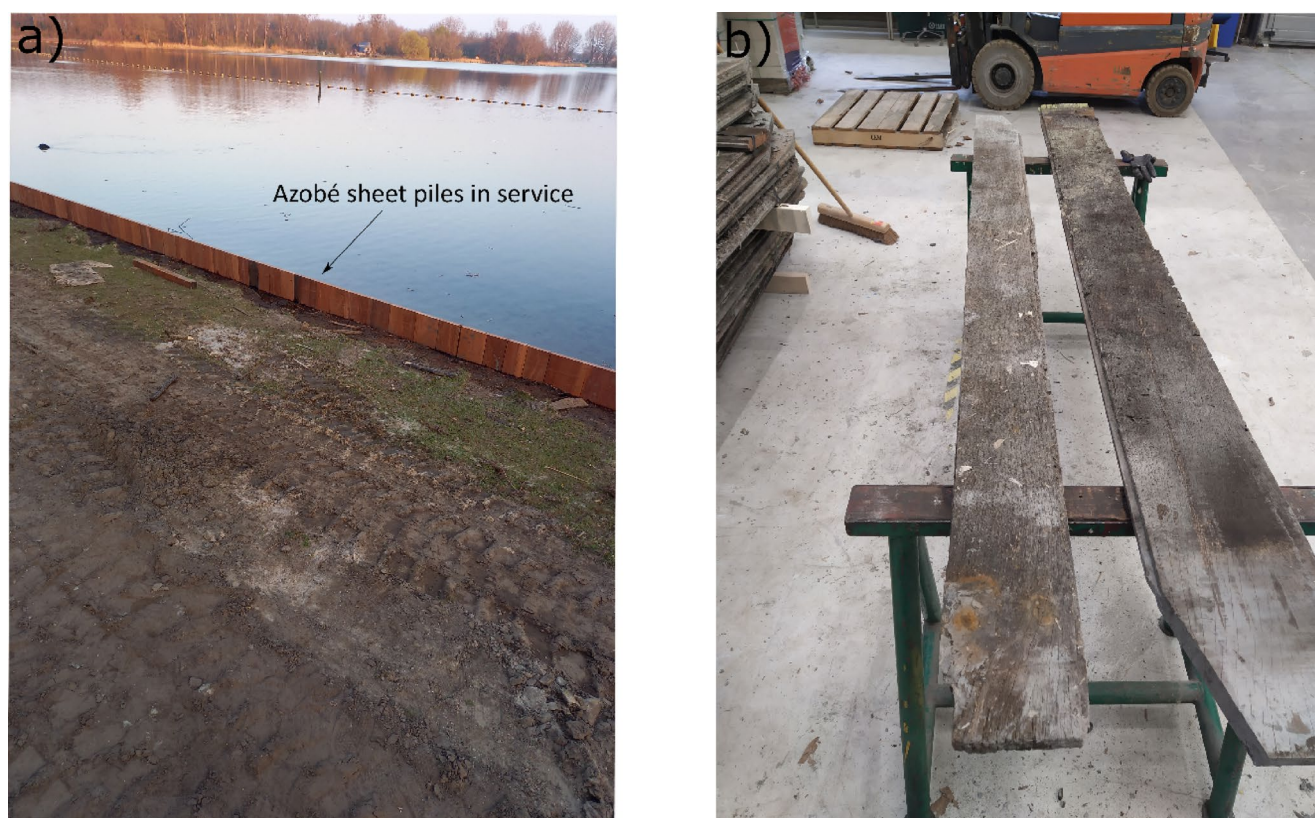
**Fig. 1** Full size azobé sheet piles (a) in service at Delftse hout, Delft, The Netherlands; (b) pulled out after 57 years of service from Medemblik, the Netherlands

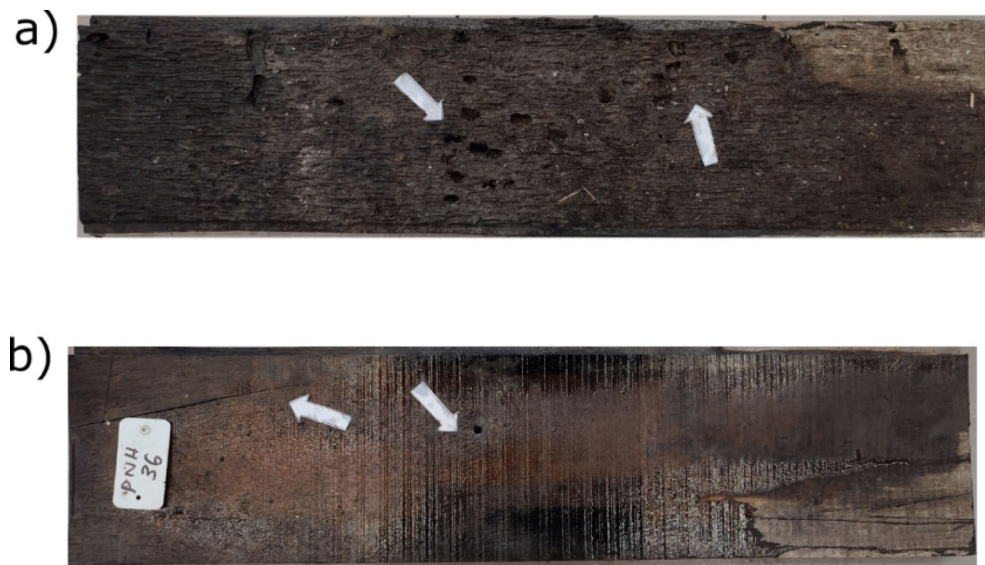
The deterioration of the recovered boards were seen to be non-uniform with respect to the face of the sheet pile. Sheet piles in service have a water-facing side and a soil-facing side. Erosion deterioration was observed in all boards throughout the length on the water side during visual assessment. Decay holes, resembling marine borer (*Teredo navalis*) attack passing through the full length of the sheet pile were observed in approximately 10% of the total boards analysed (Fig. 2). No visible deterioration was observed on the soil facing side. This outcome was also confirmed in

**Fig. 2** Detrioration on water side (a) and earth side (b), with arrows highlighting the holes due to marine borer attack

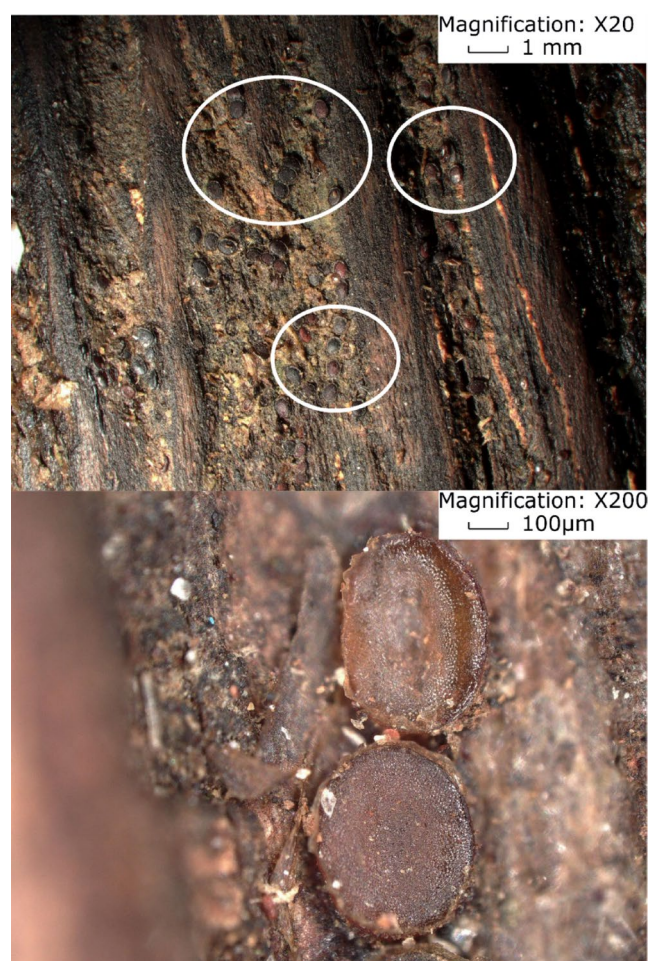
**Fig. 6** Fungi resembling worm-spored wax cup (*Orbilbia aurantiorubra*) detected under microscopic analysis on the water-facing surface of a board

indication of slow fungal decay process in progress, since the observed micro-organisms are known to be usually secondary colonisers found in hardwoods. While these fungi primarily thrive in moist, organic-rich environments, their specific effects on highly durable hardwoods like azobé remain less studied. Azobé's natural resistance to decay likely limits *Orbilbia*'s direct impact, although it may appear in later stages of degradation if the wood is compromised by more aggressive decay agents.

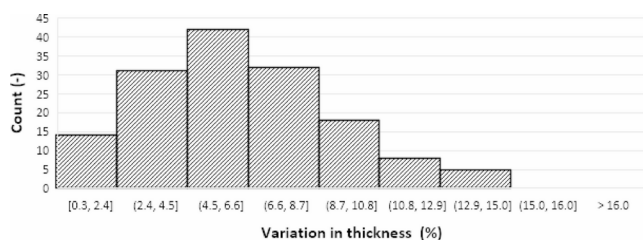
**Fig. 7** Distribution of variation in thickness obtained comparing most intact part of the sheet pile with least intact part of the sheet pile

non-parametric methods were 60 MPa and 58 MPa according to EN 384 (2016). The reduction in cross-sectional thickness was determined by measuring the most intact part of the sheet pile and least intact part of the sheet pile, see Fig. 7. Typically, bending loads govern the behavior of timber sheet piles used for bank protection; consequently, only bending test results were used in this study and the damage accumulation model.

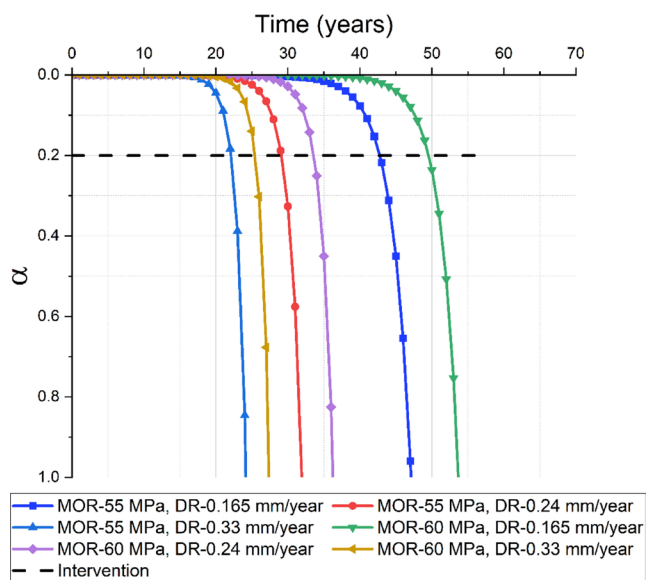
For predicting the future damage accumulation, azobé board strength corresponding to D55, D60 is considered. While full damage is accumulated when  $\alpha = 1$ , an interim value of alpha could be taken for planning any maintenance and intervention. A limit value of  $\alpha = 0.2$  is assumed as time for any intervention. The variation of damage accumulation on the sheet pile for D60 and D55 is shown in Fig. 9 for an acting bending moment of 5 kNm. It can be seen that an intervention would be required in 22 years, when a sheet pile strength D55 and a 1% decay rate (0.33 mm/year) is taken. The time for maintenance and intervention increases to 43 years when decay rate is 0.5% of the current thickness.

**Fig. 9** Damage accumulation with bending strength of 55 MPa and 60 MPa. DR- decay rate in mm/year

When the strength of the material is taken as D60 and a 0.33 mm/year, 0.24 mm/year, and 0.165 mm/year decay rate is considered, intervention would be necessary at 25, 34, and 49 years, respectively (Fig. 9).
