# Extraction of deterioration and analysis of vegetation impact effects on the south palace wall of Weiyang Palace

Weiyang Palace, the royal palace of the Western Han Dynasty, is a part of the Silk Roads: the Routes Network of Chang'an-Tianshan Corridor on the World Heritage list. The south palace wall of Weiyang Palace is a well-preserved earthen heritage site within the palace, but it is undergoing continuous deterioration due to the influence of vegetation and external environmental factors. This study pioneers the integration of high-resolution three-dimensional LiDAR scanning with multi-source data analysis, including unprecedented on-site botanical surveys, to explore the subtle effects of different vegetation types on the structural integrity of the south palace wall. Through contour line analysis and facade grid analysis, we extracted the deterioration locations of typical sections of the earthen heritage sites. And we classified the overlying vegetation types on the wall using an object-oriented classification algorithm. Our findings reveal a complex interaction between vegetation and earthen structures: paper mulberry exhibits protective qualities against erosion, while

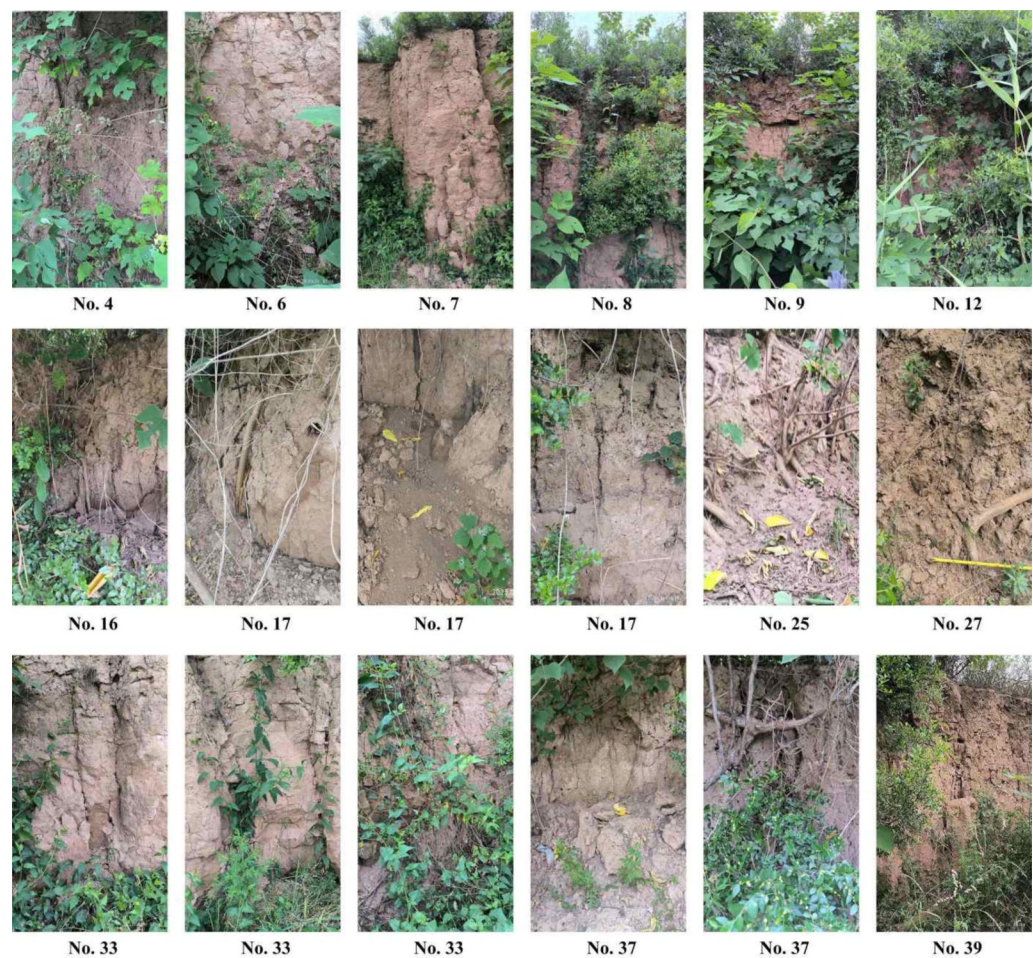
**Fig. 7** Photographs of collapses recorded on site and their corresponding digital identification numbers

Through the analysis of contour lines and the facade grid, we identified a total of 39 collapse locations on

the wall. We physically photographed and recorded 20 instances of wall collapse on-site. Upon detailed comparison with the digitally identified collapse locations, 18 out of the 20 recorded instances matched those detected by digital methods (Fig. 7). The detection accuracy for the collapse of Weiyang Palace's south palace wall was determined to be 90%. This close alignment between the collapse locations identified through digital methods and those observed during field surveys demonstrates the validity of our collapse data extraction technique,

confirming that our method accurately reflects the actual conditions of deterioration.

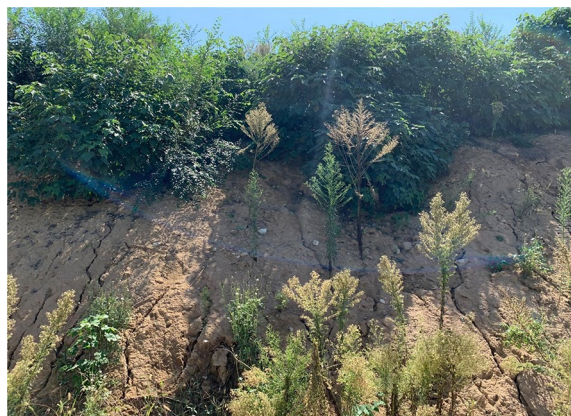
**Fig. 11** Cracks in the sections of the wall directly exposed to the external environment

The analysis indicates that deterioration on the wall is associated with the vegetation growing on them: In terms of collapses, the presence of vegetation tends to increase the likelihood of collapses, with *Ziziphus jujuba* having a greater impact; regarding cracks, paper mulberry is associated with wider cracks, while *Ziziphus jujuba* is associated with longer cracks. Areas with *Ziziphus jujuba* are particularly prone to forming cracks. Importantly, although paper mulberry has a detrimental effect on the severity of cracks, it still provides better protection than leaving the wall exposed to external environmental conditions.

completely prevent deterioration [52]. Our experimental data indicate that the south palace wall of Weiyang Palace is currently undergoing gradual deterioration. Consequently, it is imperative to use suitable materials to reinforce the wall's structure to mitigate further extensive damage [53]. *Ziziphus jujuba* significantly contributes to the formation of cracks and collapses in the wall, while paper mulberry, although slightly exacerbating the cracks, offers better protection than exposing the wall directly to external environmental conditions (Fig. 11). On the wall, paper mulberry and *Ziziphus jujuba* are in competition, with paper mulberry in a dominant position. Given these dynamics, we recommend employing chemical methods to eradicate *Ziziphus jujuba* to prevent further deterioration. Until an appropriate man-made shelter is created for the wall, the paper mulberry trees on it should be preserved to avoid direct erosion by wind and rain.
