# Success Indicators of Progressive Ecological Rehabilitation of Sites around a Tropical Highland Open Pit Mine

Lefranc Busane Basima<sup>1,2\*</sup>

**How to cite this paper:** Basima, L. B., Muhigwa, J.-B. B., & Cubaka, A. K. (2025). Success Indicators of Progressive Ecological Rehabilitation of Sites around a Tropical Highland Open Pit Mine. *Journal of Geoscience and Environment Protection*, 13, 415-454. <https://doi.org/10.4236/gep.2025.134022>

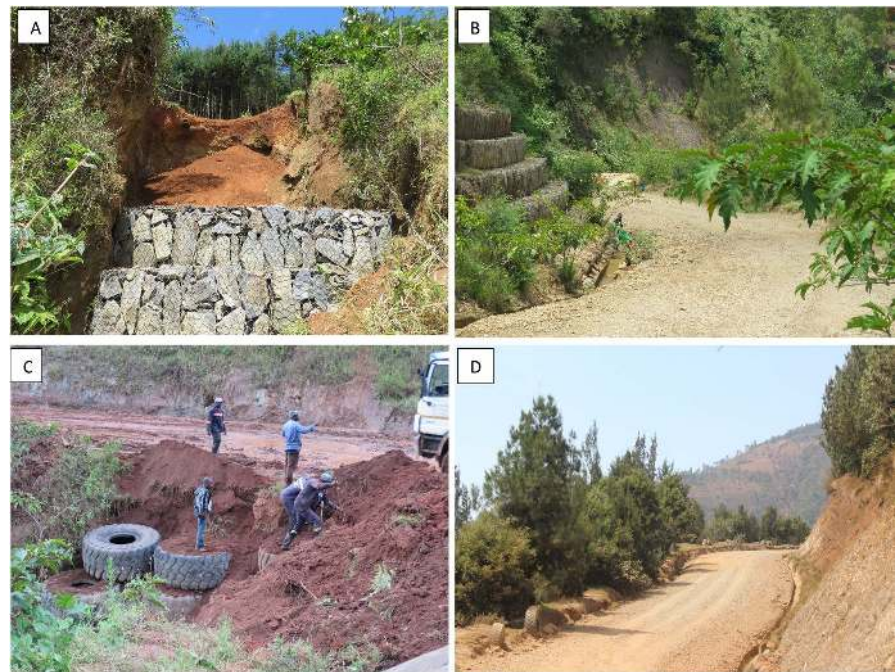
**Figure 2.** Gabion baskets in support of the main access road (A) and a wall side (B); tires being positioned to support an access road with drainage (C) and concrete side drains on the wall side (D).

The infrastructure was developed to support the progressive rehabilitation including concrete drains, HDPE pipe drains, gabion baskets for side walls and roads support, reused tires for slope stabilization and concrete masonry. These are shown in **Figure 2**.
