## Removal of mesh track on an upland blanket peatland leads to changes in vegetation composition and structure

Jessica Williams-Mounsey<sup>a,\*</sup>, Alistair Crowle<sup>b</sup>, Richard Grayson<sup>a</sup>, Joseph Holden<sup>a</sup><sup>a</sup> *Water@leeds, School of Geography, University of Leeds, Leeds, LS2 9JT, UK*<sup>b</sup> *Natural England, Unex House, Bourges Boulevard, Peterborough, PE1 1NG, UK*

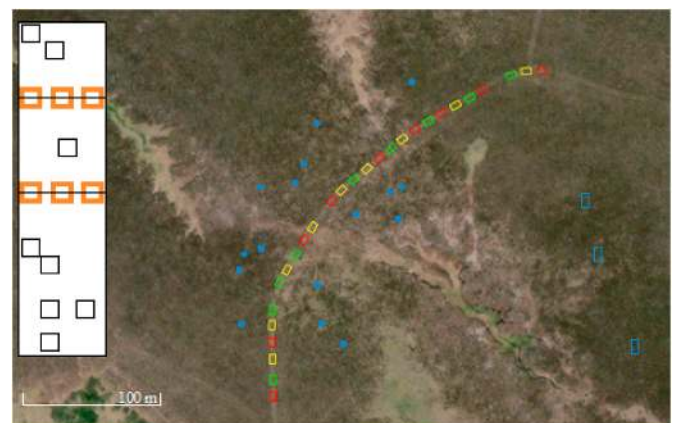
**Fig. 1.** Layout of plots (indicated by rectangles) along the track. Red plots indicate unprepared prior to removal (UR) treatment locations, green left in place track (LP) treatment and yellow mown prior to removal (MR) treatment. Blue dots represent individual random control quadrats and the blue rectangular plots contained 8 control quadrats each. The inset figure shows a schematic example layout of track quadrat points. (For interpretation of the references to colour in this figure legend, the reader is referred to the Web version of this article.)

Three treatments were applied to plots along the 270 m of track (Fig. 1) which were: i) track left in place (LP); ii) mown with a quad-pulled flail-mower prior to removal, the aim of which was to ease removal and leave a short functional layer (MR), and iii) no preparation (mowing or cutting) of vegetation prior to removal (UR). Nine replicates of each treatment type were created, with three of each kind on one of the following: top, mid or bottom of slope position, giving 27 plots in total plots were 7 m × 2.5 m (plot area 17.5 m<sup>2</sup>). A total of 126 m of track was removed, and a 3 m buffer of track was left between each plot to minimise movement of overland flow sediment and debris between plots. The track was cut manually using a Stihl circular saw and sections were then lifted and removed using a modified clamp on a low ground pressure tracked digger (Fig. 2). The digger was positioned to the side of the track to minimise disturbance to the experimental plots on the track, although disturbance to the surrounding vegetation occurred, which we discuss later.

Vegetation and bare peat surveys were carried out before the track was removed on all plots to establish a baseline for each survey point; these took place approximately five years after vehicular use on the track ceased. Immediately after removal, the plots coincident with where the track had been removed were resurveyed. A 'lite' survey (involving four randomly selected quadrats from the full eight and all the linear quadrats) on all plots from the two treatments where track was removed was carried out in the following spring (2021) to assess for interim changes, followed by full surveys in autumn 2021 and mid-summer 2022 of all survey points including the control points. Three control plots mirroring the topography of the track were selected, situated on undisturbed blanket peat ~100 m from the mesh track area to avoid undue influence from the track (Fig. 1). A further 16 random control points sitting >10 m from the track edge on the up and down-slope sides were also selected (Fig. 1).

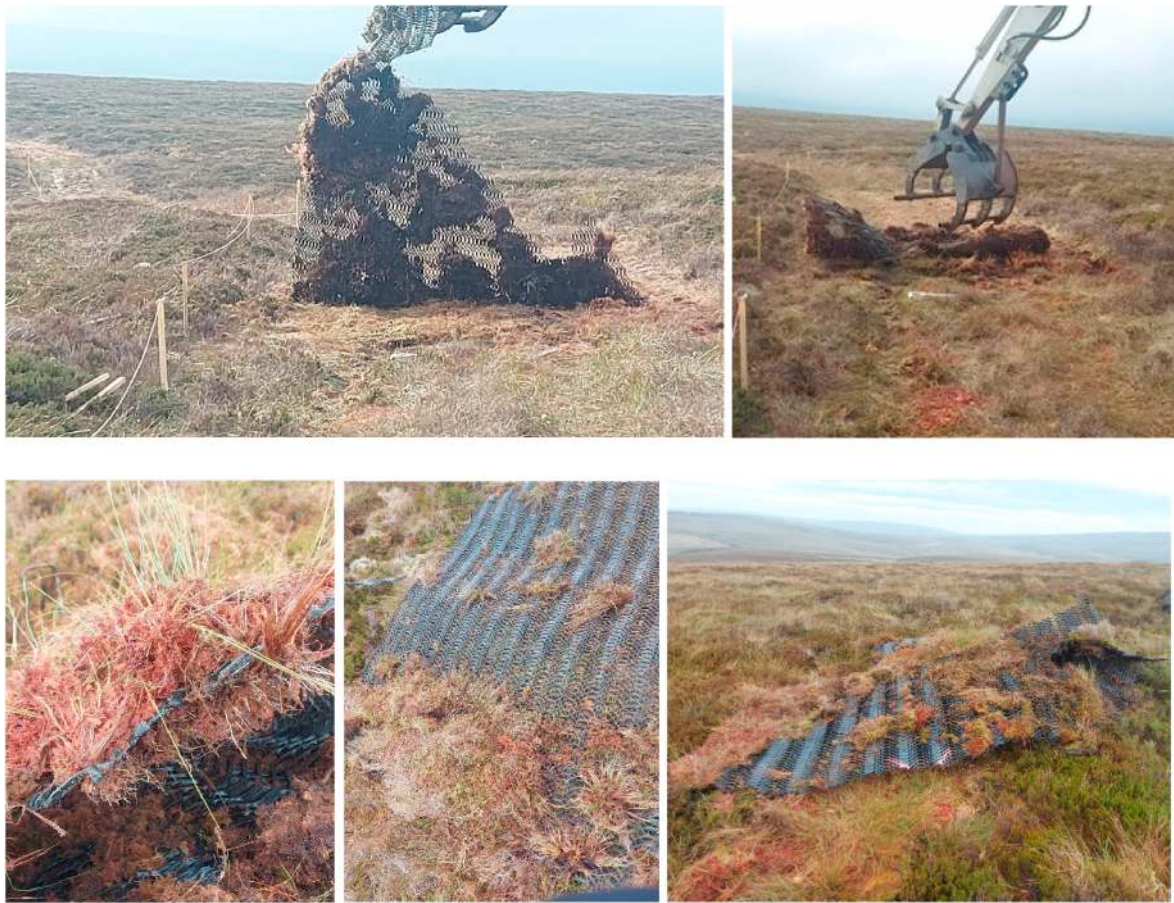
**Fig. 2.** Removal of sections of mesh track from the study site showing digger set-up and the extensive surficial vegetation loss that occurred during the removal process.

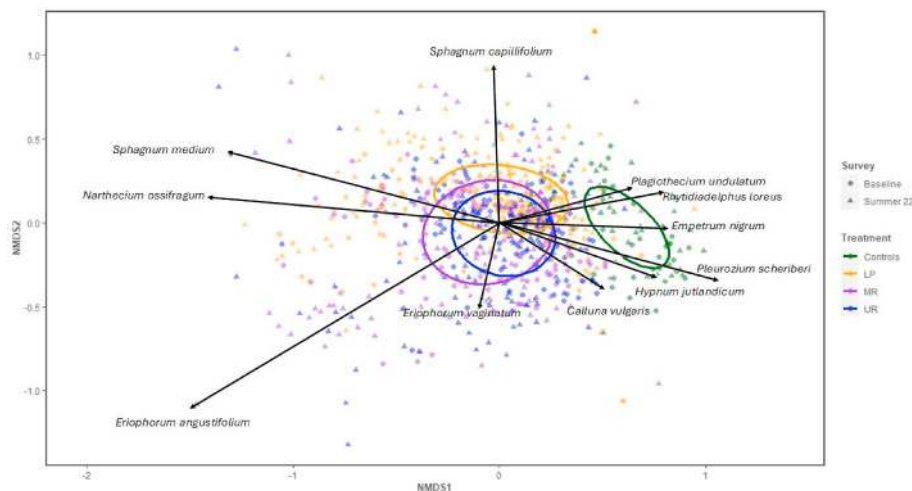
**Fig. 3.** NMDS using Bray Curtis distance showing differences and overlaps between treatments (MR – mown removed, UR – unprepared removed and LP – left in place) and control, highlighting the divergences in the assemblage, with the species acting as major drivers of variation highlighted.

A total of 29 species were identified in the quadrats sampled in the undisturbed control plots, compared to 45 species in the treatment plots, with only two of these species in the controls being non-characteristic bog species (*Campylopus* sp. moss and *Polytrichum commune*) and both present at very low densities (<1% of total quadrat squares). While there is broad similarity in the assemblage between the controls and treatments, the driver for the low similarity found between the locations appears to be the abundance of the species. Non-metric multidimensional scaling (NMDS) using Bray Curtis distance provides visualization of these difference in vegetation assemblage composition between the control and treatment plots (Fig. 3) for baseline and summer 2022, stress = 0.21.

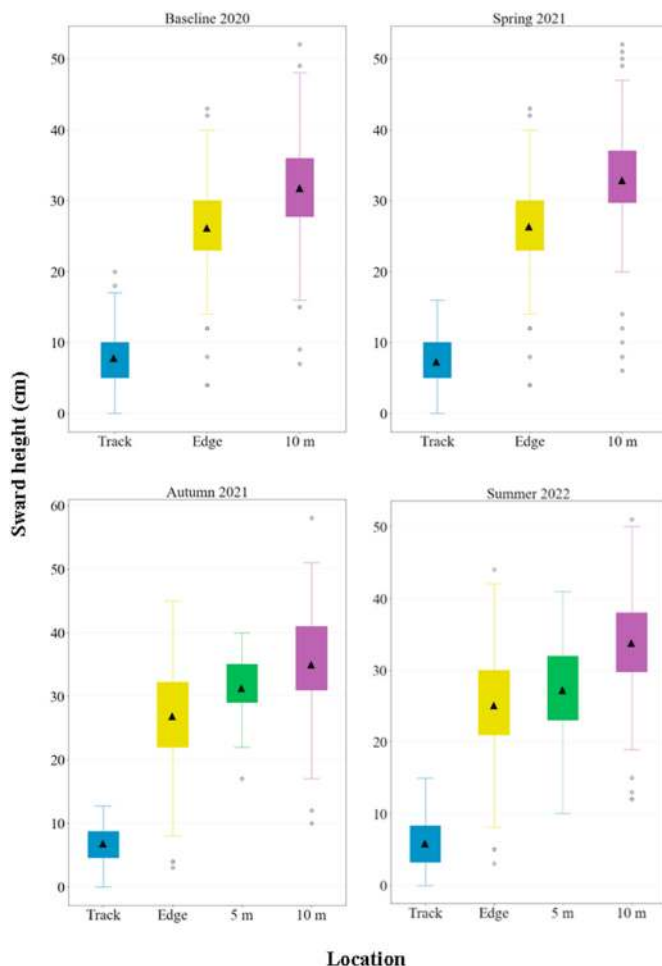
Fig. 4. Variation in sward height measured at three points; track, 1 m away from track edge and 10 m away from track edge, with an additional 5 m transect included in autumn 2021 and summer 2022. The median is represented by the black triangle, box ends represent IQ1 and IQ3, whiskers represent values up to 1.5 times the IQ range with fliers representing the extreme outliers.

Sward height was found to be significantly lower for all sets of track measurements compared to the 1 m edge and 10 m control transects ( $p < 0.001$ ). Both 1 m and 10 m transects had significantly different mean values over the survey period (mean  $26.3 (\pm 8.18)$  cm and  $33.2 (\pm 8.17)$  cm respectively) than the track values (Fig. 4). A significant difference ( $p < 0.001$ ) between the 5 m and 10 m mean sward heights (mean  $27 (\pm 6.32)$  cm and  $33.6 (\pm 8.04)$  cm respectively) in summer 2022 was also found. Treatments played a role in reducing sward height on the track; but individual treatments did not significantly influence the edge transect sward height.

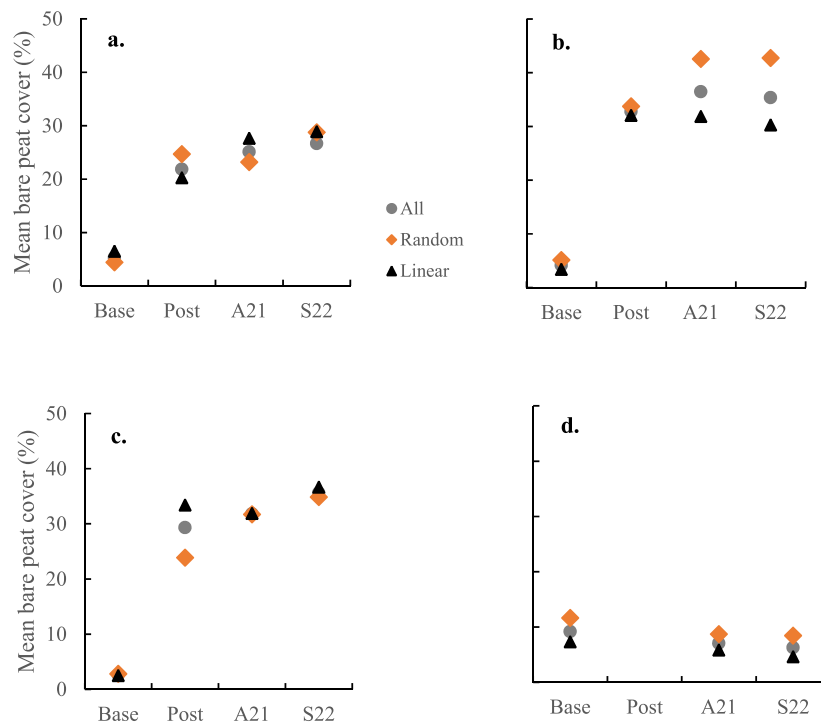
**Fig. 5.** Changes to the mean cover of bare peat across quadrat survey points at baseline (Base), post-removal (Post – Mown and unprepared removed – MR and UR - only), autumn 2021 (A21) and summer 2022 (S22); **a.** all treatments combined **b.** MR **c.** UR and **d.** LP (left in place).

With track removal, bare peat incidence increased almost threefold from being present in 18% of quadrats at baseline (68 quadrats) to 41% of quadrats immediately post removal. By 19 months post removal, in summer 2022, bare peat was present in 52% of quadrats. The mean bare peat coverage across track all quadrat locations (ruts, centre and random) and treatment types at baseline was  $5.3 (\pm 15.7)\%$ , while in the plots selected for track removal it was  $3.4 (\pm 10.7)\%$  at baseline. Broken down by quadrat location at baseline, linear quadrats (all treatments) had a mean of  $6.5 (\pm 17.8)\%$  and random quadrats (all treatments)  $4.4 (\pm 13.9)\%$  bare peat coverage. Bare peat was not recorded in any of the control plots or random control quadrats. Despite some variation there was no significant difference between the MR and UR treatment plots in extent of bare peat at baseline (Fig. 5). Further comparative analysis for the removed track treatments is shown in Table 3.

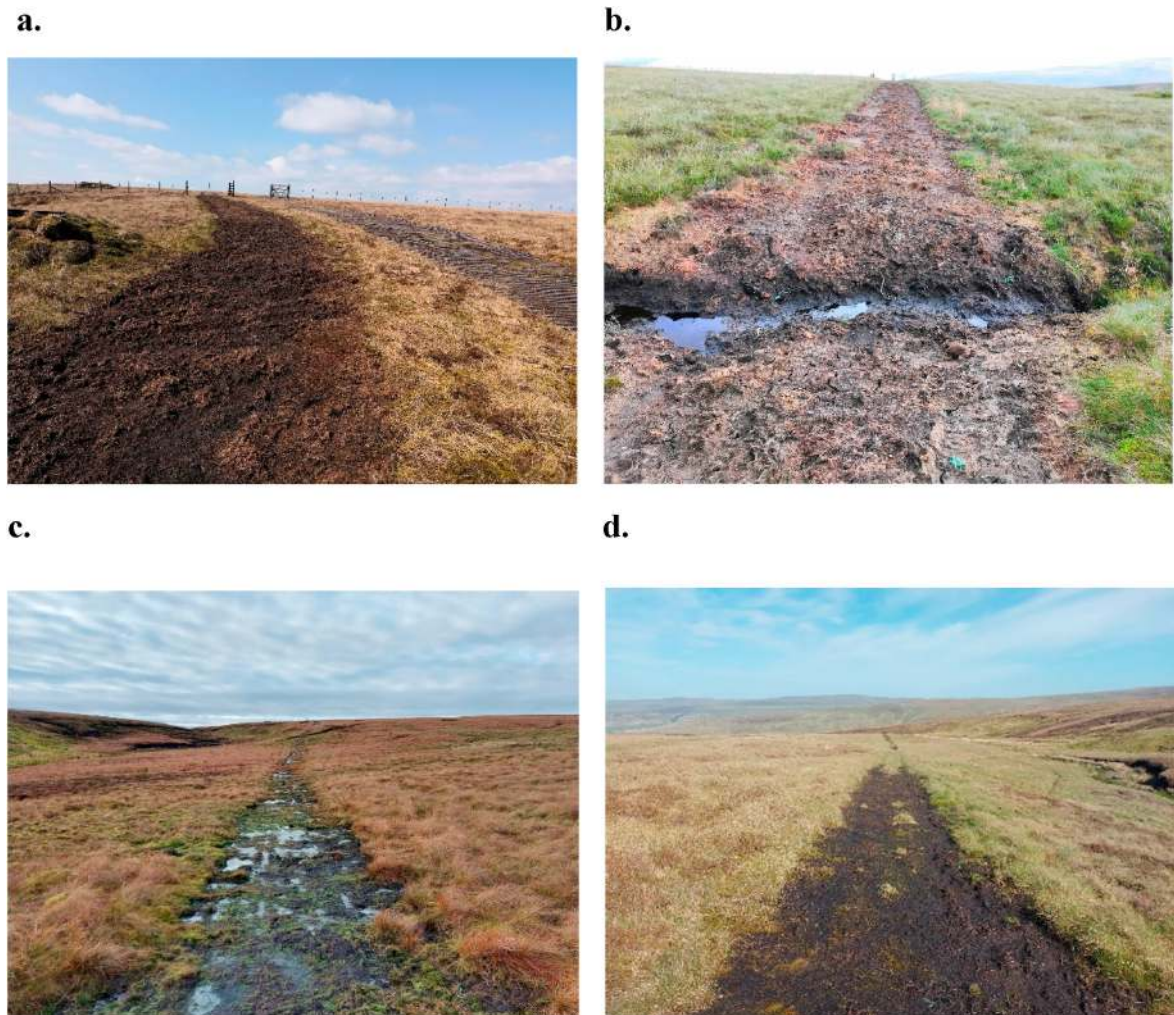
**Fig. 6.** Track removed from an estate in the North Pennines showing it at four different time intervals post-removal a. 15 months post-removal, April 2019 (left-hand track, a new track was laid adjacent) b. 18 months post-removal showing water eroded channel c. 3 years post-removal d. 4.25 years post-removal (shown on right of image parallel to the new mesh track).

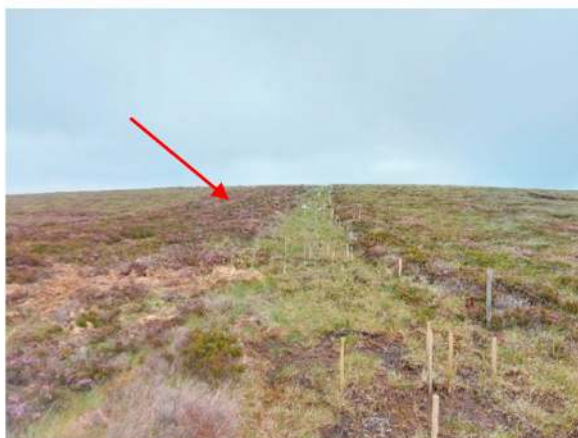
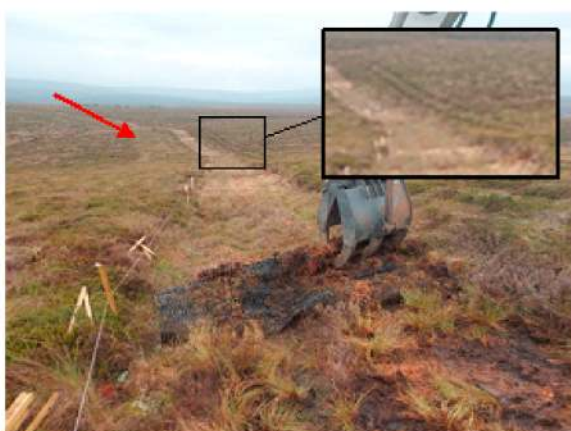
**Fig. 7.** Images showing variation in the sward height along track sides, including a visible line where *C. vulgaris* growth occurs more vigorously, on the upslope side (a.) on the downslope side (b.) the effect is reversed with more vigorous growth beyond the 5 m. Damage from the removal digger is also highlighted.

Edge effects are an important consideration, as they effectively extend the footprint of the track. Sward height showed significant variation throughout the study, not solely on the track but also in transects taken 5 m from the track edges. A significant edge effect was found extending out from the track with a maximum extent of 10 m (nanotope features and vegetation were at the upper end of the size scale at 10 m and therefore this was judged to be the limit of the track influence for our site). Our findings of edge effects are supportive of those of Dabros et al. (2011) and Willier et al. (2022) who found reduced cover in taller woody vegetation species along seismic lines in Boreal peatlands in Canada. McKendrick-Smith and Kathryn (2016) previously recorded a shallower downslope water-table depth along the track section we studied, particularly within the 1 m distance, while on the upslope side the water table was found to be deeper. A distinct visible vegetation line is observable in images (Fig. 7a and b) which may correspond with this variation, and is supported by research showing that water-table variations impact the make-up of the plant communities (Andersen et al., 2017). The removal process also led to depressed sward height post-removal on the upslope side of the track edge up to 7 m from the track (Fig. 7b).
