# Above-ground durability of painted and unpainted Australian and imported timbers in an L-joint field test after 35 years

## Research Article

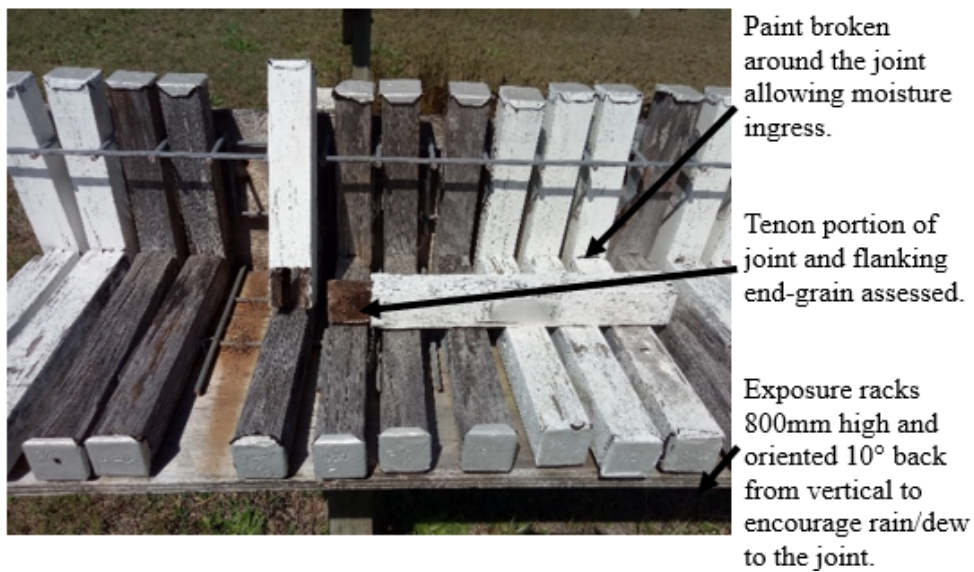
Figure 2

# L-joints at Cleveland

L-joints were placed 800 mm above ground on exposure racks that were constructed using CCA-treated plywood and durable framing timbers. Spacers were fixed to the racks to support L-joints, preventing them from coming into direct contact with the plywood frame and to provide consistent spacing between each joint. The racks face north, and each rack was constructed such that L-joints placed on it are oriented 10° backward from vertical. Each rack had drain holes at the rear to prevent water pooling.

situated 65 km north of Brisbane in Queensland, Australia in 1987 (-26.957141, 152.961085). The Beerburrum site was reclaimed in 2007, and L-joints were moved to Cleveland, situated 25 km east of Brisbane (-27.526137, 153.247547). At this location, L-joints were initially installed under a sparse canopy of eucalypt foliage, so that leaf litter intermittently reduced the ventilation around the L-joints. In 2017, partial site reclamation again necessitated that the L-joints be moved to an open area that had become available at the Cleveland site.
