Boštjan Lesar[1], Redžo Hasanagić[2], Mohsen Bahmani[3], Miha Humar[1*]

Assessment of Condition of Wooden Mill in Kovačevići Area in Bosnia and Herzegovina

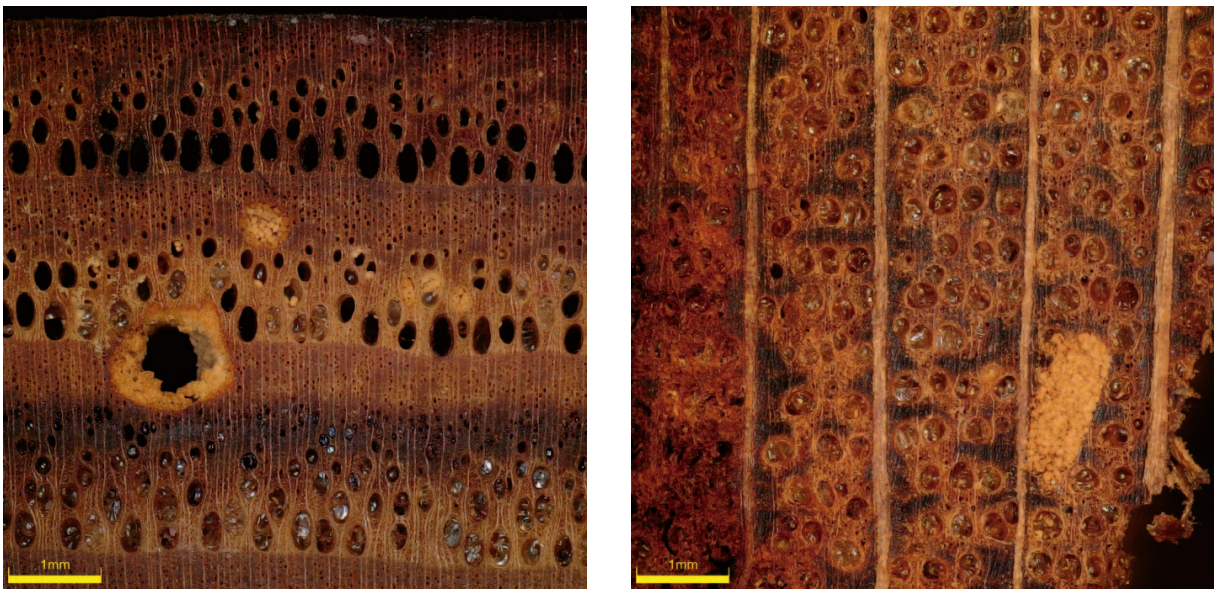
Microscopic analysis revealed that the mill in question consists predominantly of sweet chestnut (*C. sativa*) and European white oak (*Quercus sp*.) (Figure 2). The ring-porous structure is clearly visible in the images (Figure 2). The presence of the wide parenchyma rays distinguishes the oak from the sweet chestnut (Wagenführ, 2014).

Figure 2 Cross-section of sweet chestnut (*C. sativa*) (A) and oak (*Quercus* spp.) wood sample (B); cross-section holes are caused by insect damage

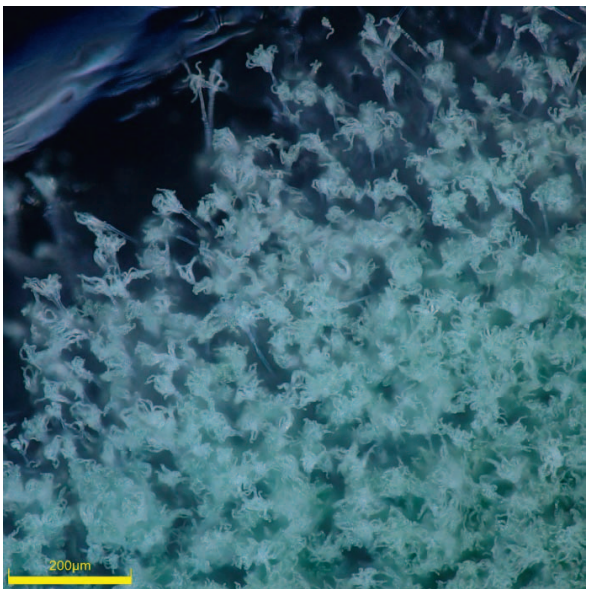
Figure 4 Fungal conidia that developed from collected spores belonging to genus *Penicillium*
Slika 4. Konidije gljivica koje su se razvile iz nakupina spora roda *Penicillium*

One of the prerequisites for fungal infestation is the presence of fungal spores. Therefore, the spore concentration in the mill (1625 CFU/m^3) and before the mill (3480 CFU/m^3) was determined. Usually, between 360 and 1230 CFU/m^3 are reported in the air (Flores *et al*., 2014). As higher values are reported in the vicinity of the mill, this indicates the potential of the fungus in the environment. From the microscopic analysis, it can be concluded that the majority of the colonies identified belong to the genus *Penicillium* (Figure 4). *Penicillium* is a genus of ascomycetous fungi that is part of the mycobiome of several species and is of great importance in the natural environment.

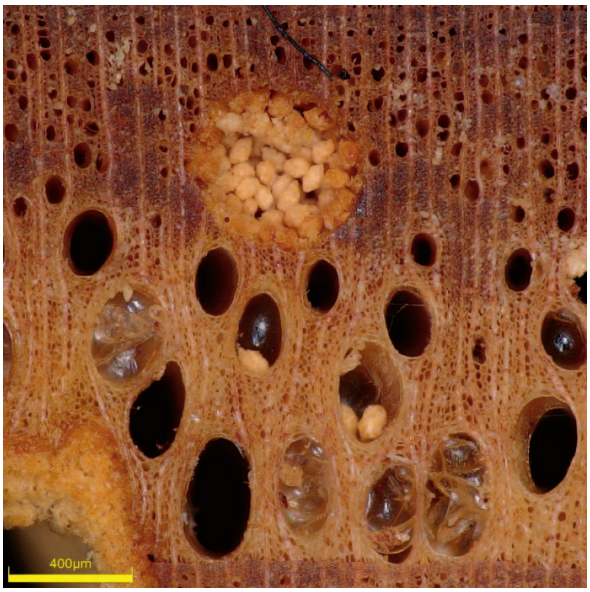
Insect galleries were mainly found on the outside of the structure. The interior was at least partially protected by smoke deposits. The chimney without a flue was located inside the mill. The smoke could therefore easily spread over the entire volume of the building and escape through the opening in the roof. It should be remembered that the mills also operated at night, so the fire was the source of light and heat. Rahmat and co-workers (2020) reported that condensed gases from wood burning have fungicidal effect. As can be seen from the XRF spectra of the corresponding deposits, they contain high concentrations of iron (Fe), sulphur (S), chlorine (Cl), cadmium (Cd) and manganese (Mn). These elements are assumed to have originated from the corrosion of metal roof and smoke (Humar, 2010). However, it should be noted that these deposits were present only on the interior side of the beams.

Figure 9 Insect hole in sweet chestnut wood filled with debris typical for beetles from genus *Anobium*
Slika 9. Rupe od kukaca u drvu pitomog kestena ispunjene ostatcima tipičnima za kornjaše iz roda *Anobium*

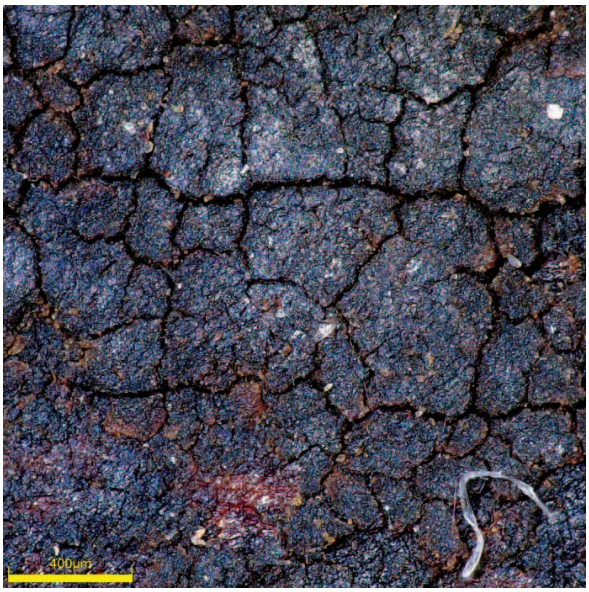
Figure 10 Deposits on oak beams surface in mill interior
Slika 10. Naslage na površini hrastovih greda u unutrašnjosti mlina
