# A study on deterioration and residual service life of recovered azobé (*Lophira alata*) sheet piles

Abhijith Kamath<sup>1</sup> · Michele Mirra<sup>1</sup> · Geert Ravenshorst<sup>1</sup> · Jan-Willem van de Kuilen<sup>1,2</sup>

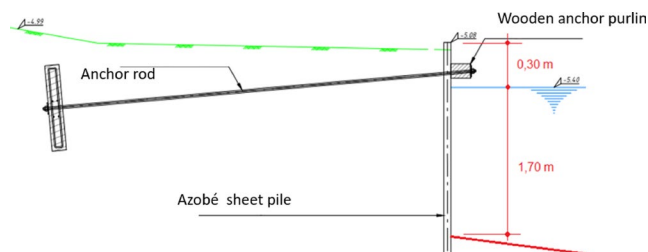
**Fig. 8** Cross section of azobé sheet pile with a retaining height of 2 m, Taken from (Kamath et al. 2025)

The sheet piles investigated in this study were designed for a soil-retaining height of 2 m (Fig. 8). The soil profile of the location included different layers of sand, silt and clay. Since little knowledge is available about the soil strength parameters, the ones given in Table 2 are assumed. Average
